7 LIFELINES

This report presents findings of earthquake damage to lifeline facilities. Topics included are dams, water supply, sewage, power, communications, liquid fuels, and general transportation. Port facility structural and geotechnical aspects of the earthquake are discussed in Chapter 5—Industrial Facilities. Performance of bridges is discussed in Chapter 6—Bridges.

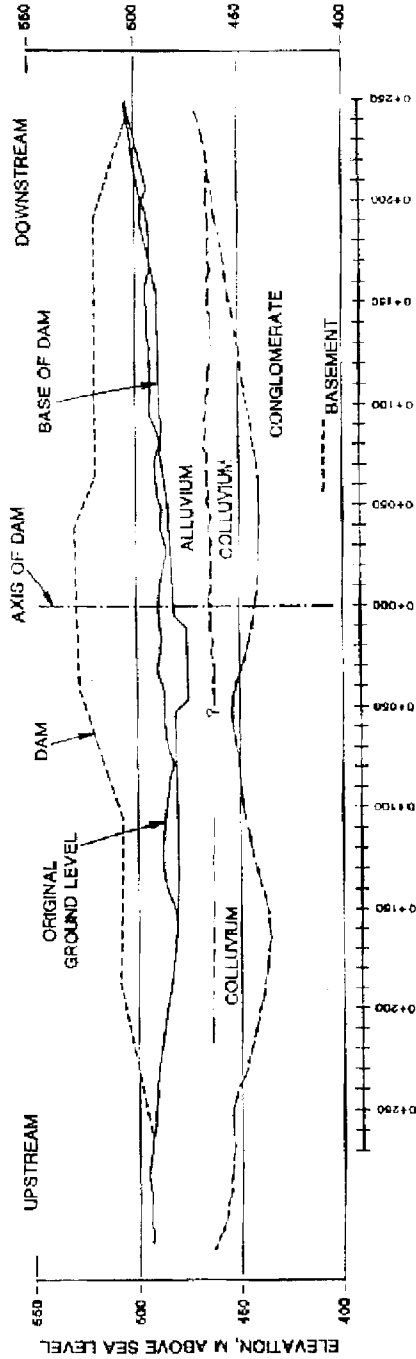
Figure 7-2 Cross section of Arenal dam and of the foundation materials on which it is built.

Arenal dam has a height of 80m and impounds a world class reservoir. The dam is rockfill with an impervious core and was built on alluvium (Figure 7-2). The dam is about 210 km from the epicenter of the earthquake, a distance at which the attenuated motions apparently did not trigger the strong motion instruments in the region.

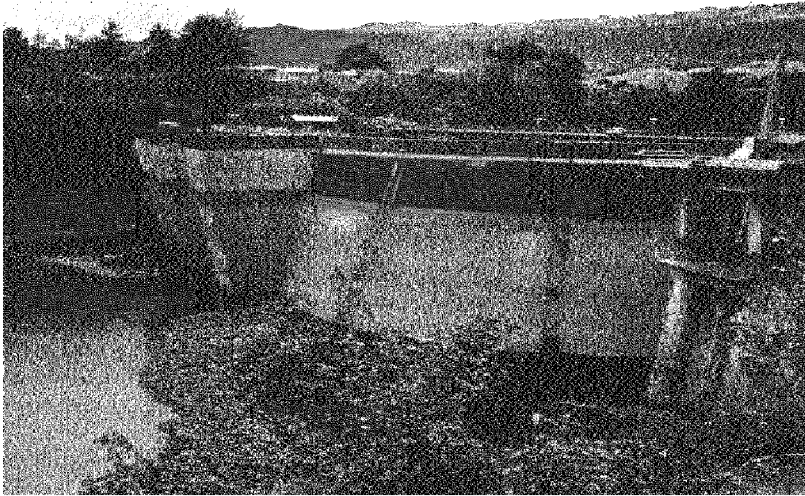
Figure 7-3 View of Cachi dam from upstream.

Cachi dam is a concrete arch structure 80m in height and is located 86 km from the epicenter. Figure 7-3 shows the appearance of the structure from upstream. Figure 7-4 shows a view of Cachi dam from downstream, including the spillways

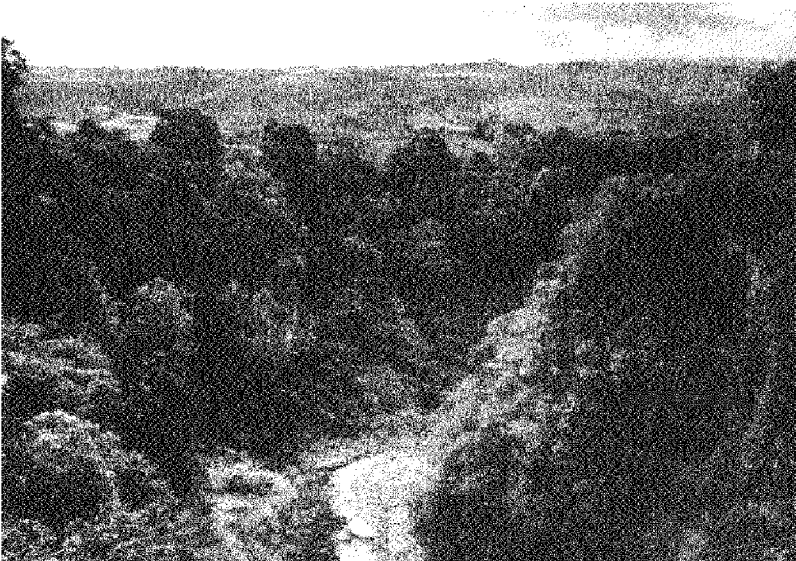
Figure 7-5 The narrow gorge of the Rio Reventazon below Cachi dam.

The dam is built in a narrow gorge of the Rio Reventazon, seen in Figure 7-5, in which the restriction appears to have been caused by thick lava flows laid over indurated conglomerates. The structural association and lithology of the rocks into which the valley was incised is shown in Figure 7-6. The site is composed of strongly indurated conglomerates over which are thin, discontinuous alluvial and lacustrine deposits overlain the sheet-like coverings of lavas and tuffs.
